Engineering Geology

Numerical analysis of the causes of face slab cracks in Gongboxia rockfill dam

Zijian Wang^a, Sihong Liu^{a,*}, Luis Vallejo^b, Liujiang Wang^a

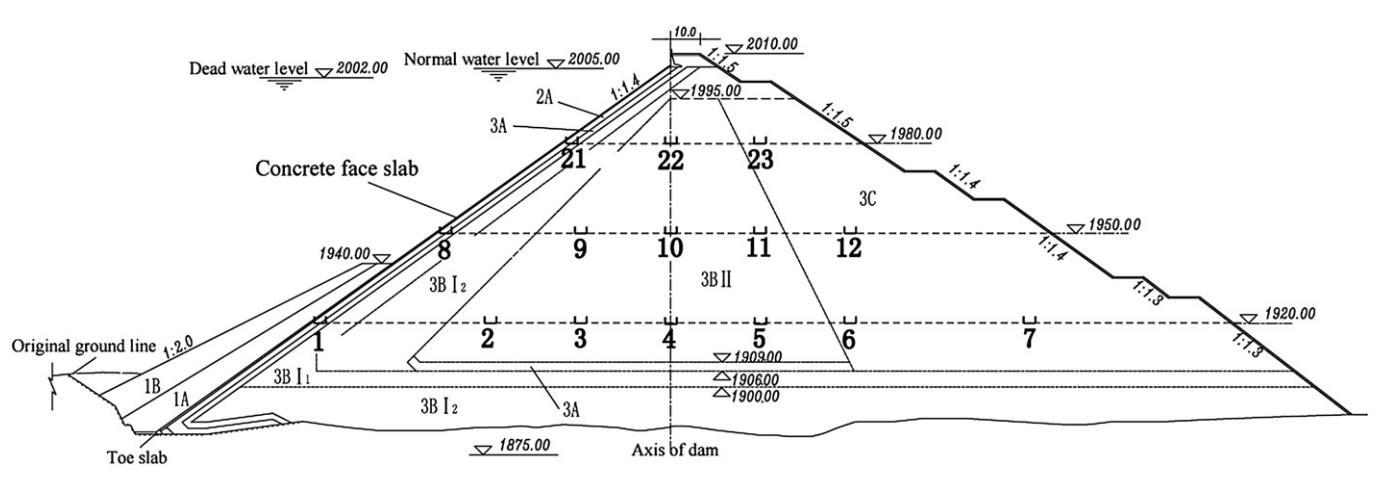
Fig. 1. Distribution of water level settlement gauges at the typical transect (0 + 130 m).

The maximum dam height is 132.2 m. The main materials in constructing compacted rockfill dams are the main rockfill materials (3BI, 3BII) and downstream rockfill materials (3C), as shown in Fig. 1. There are 26 water level settlement gauges put in the whole dam to monitor its settlement. Fig. 1 shows the distribution of several water level settlement gauges at the typical transect (0 + 130 m).

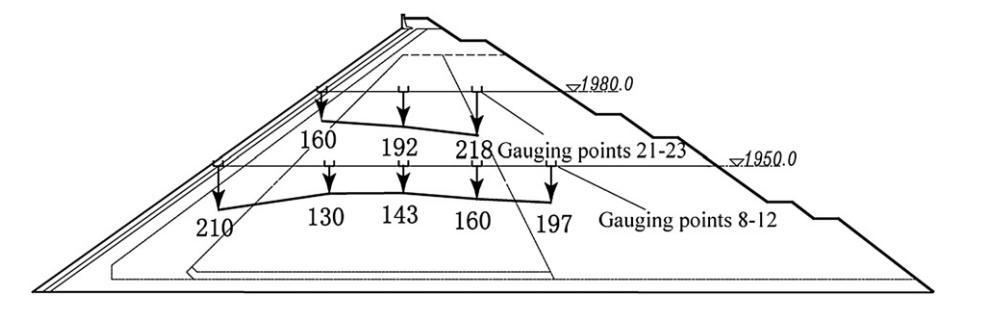
Fig. 4. Settlement of the gauging points after impounding (mm).

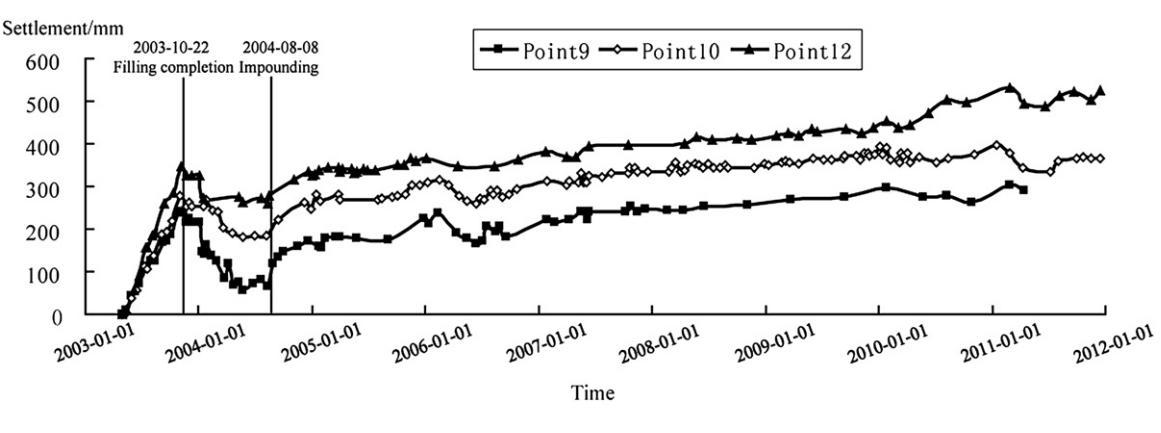
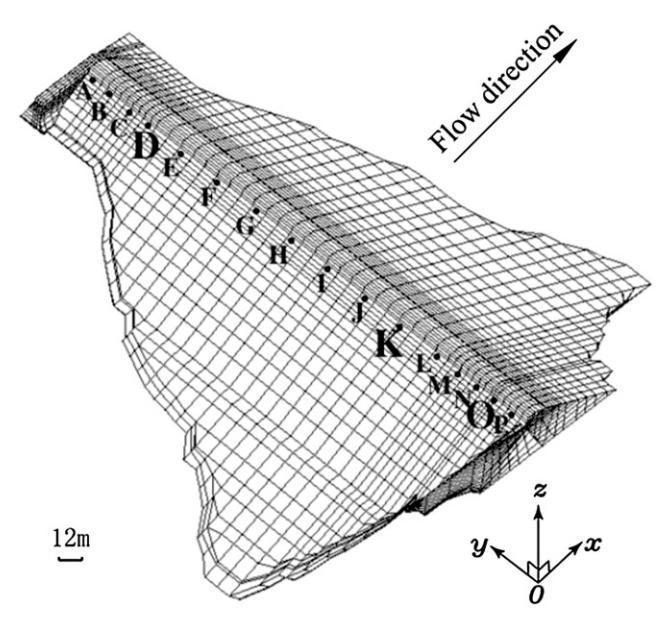
Fig. 5 shows the three-dimensional finite element mesh of Gongboxia CFRD. The number of elements and nodes is 37,024 and 39,474, respectively. Goodman elements are used for joint elements between the face slabs and cushion materials (Goodman et al., 1968).

Fig. 5. Three-dimensional finite element mesh and selected points.

In order to pay close attention to the tensile stress occurring at the top of the face slab, points A–P are selected (cf. Fig. 5). The results reveal that pressure stress occurs in the riverbed (points J–M) and there exists tensile stress on both sides of the bank (points A–I and N–P). Fig. 11 shows the development of stress at points D, K and O. It can be seen that the stresses in these three places are all increasing but will stabilize after 2016. D and O are located on both banks that show tensile stresses. These tensile stresses result in more cracks occurring on the banks relative to the riverbed.

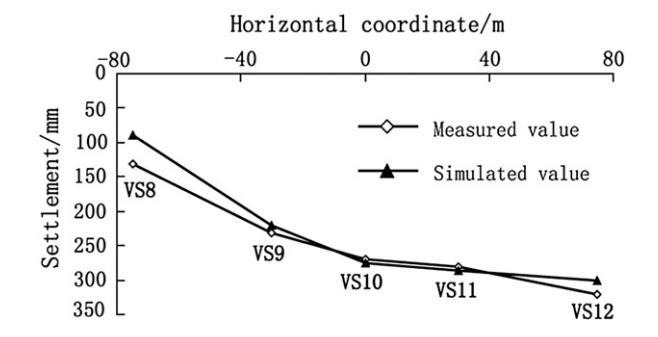
Fig. 6. Comparison between simulated and measured settlement values at the end of construction.

The Duncan-Chang (E-B) model is used for rockfill materials (Duncan and Chang, 1970). The parameters of this model are determined by lab tests and are shown in Table 1. Dam filling construction, face slab concrete pouring and water impounding are all simulated in line with these parameters. Fig. 6 shows the simulated settlement value and the measured settlement value of the gauging points 8–12 (cf. Fig. 1) at the end of the construction. It reveals that simulated results closely mirror the measured results, in turn demonstrating that the parameters in the Duncan-Chang model are reasonable.

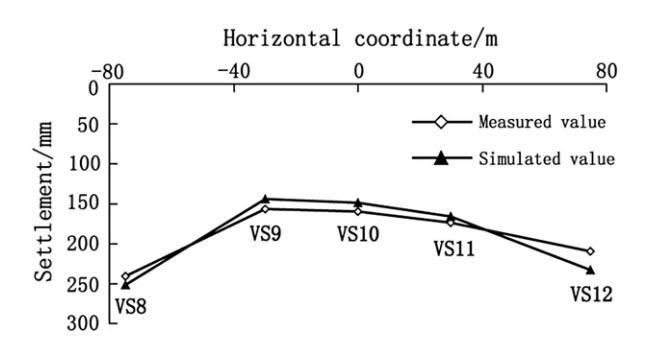
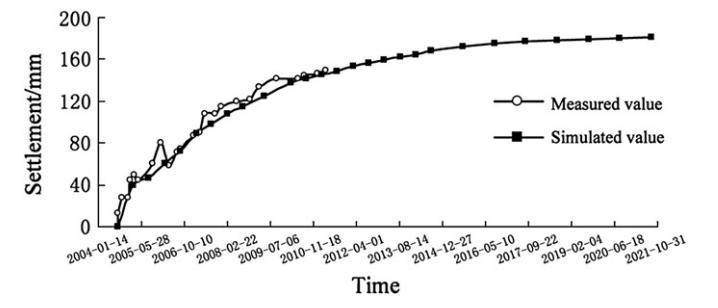
Fig. 8. Processes of the simulated and measured settlements at gauging point 9.

Fig. 7 shows the increment of simulated and measured rheological value of the gauging points 8–12 from August 22, 2004 to August 22, 2011. It can be seen that simulated results are similar to the measured results. Fig. 8 shows the processes of the simulated and measured settlements at gauging point 9. The simulated and measured settlements also match well. Predicted settlement is also shown in Fig. 8. It can be seen that the tendency of settlement forming will slow down after 2016. That is to say, the rheological deformation of the rockfill will slow down after 2016.

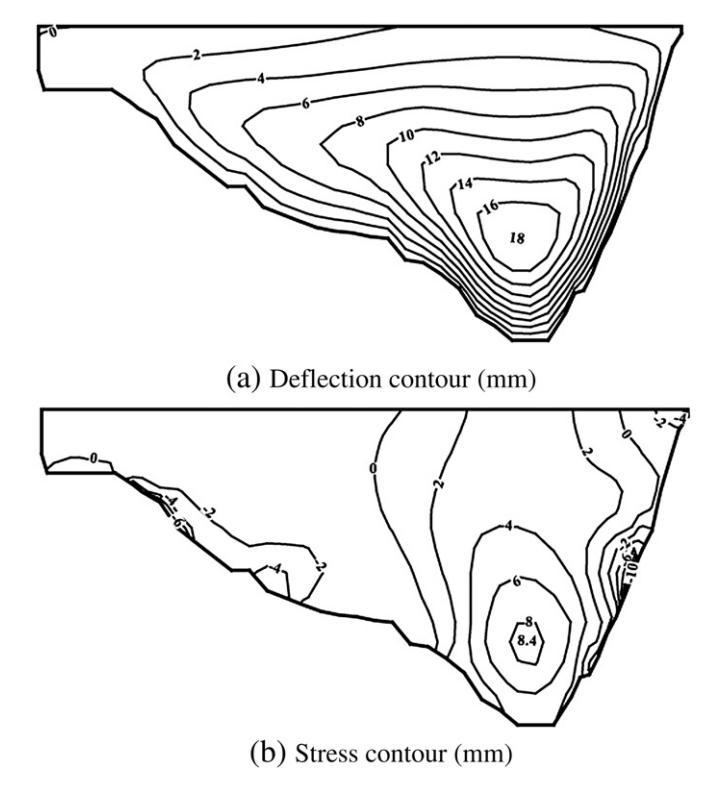
The simulated deflections and axial stresses of the face slab in 2004 and 2016 are shown in Figs. 9 and 10, respectively. It can be seen from these figures that deflection has a tendency to spread to both sides of the bank. The maximum amount of deflection occurs at 1/3 dam height,

ranging from 18.0 cm (2004) to 24.3 cm (2016). The pressure stress (+) mainly occurs on the riverbed, while tensile stress (-) occurs on both sides of the bank. The maximum pressure stress is 8.4 MPa during impounding, increasing to 9.0 MPa by 2016. Generally speaking, the pressure stress of the face slab is not big enough to explain cracking, while tensile stress occurring at the top of the face slabs on both sides of the bank is more likely to lead to cracks.

Fig. 9. Face slab's deflection and stress in 2004.

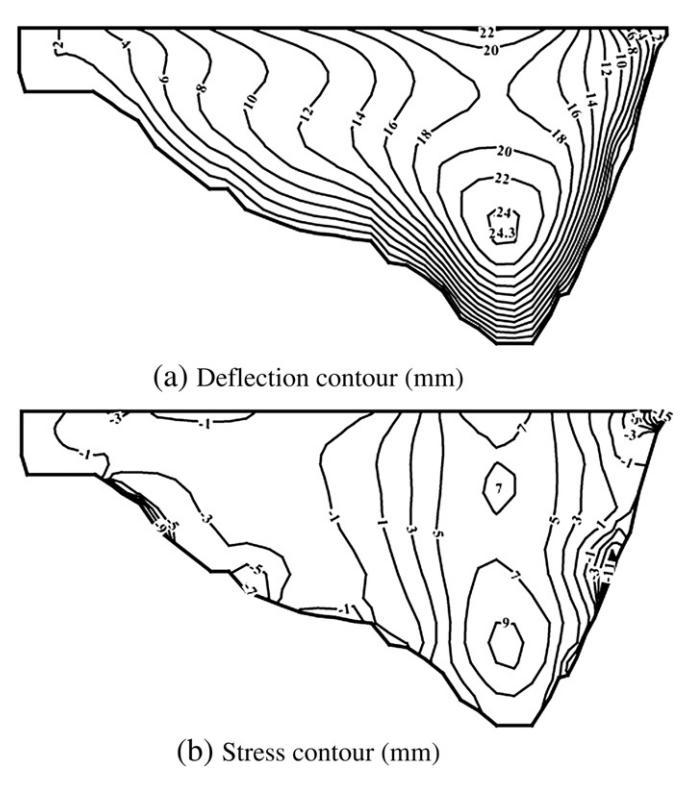
Fig. 10. Face slab's deflection and stress in 2016.

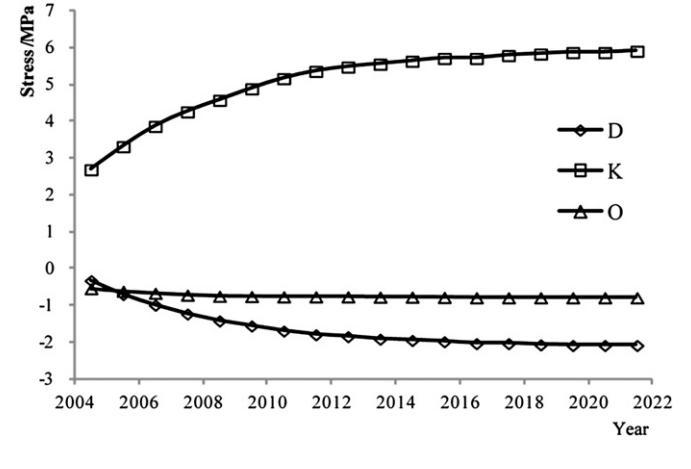
Fig. 11. Stress process in points D, K and O.

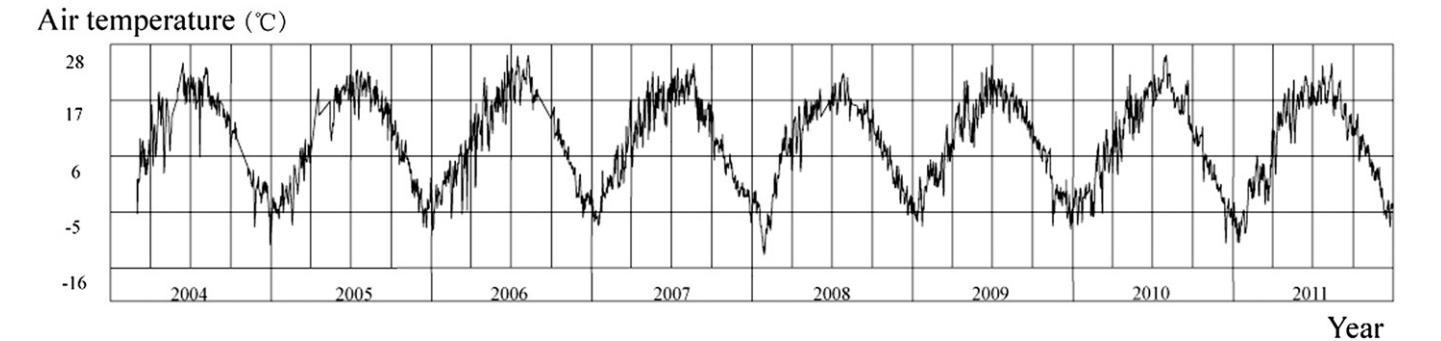
Fig. 12. Daily mean air temperature observations.

There are complete air temperature observations in this project (cf. Fig. 12). The temperature curve is similar to that of a cosine function, so the temperature can be expressed by the following formula:

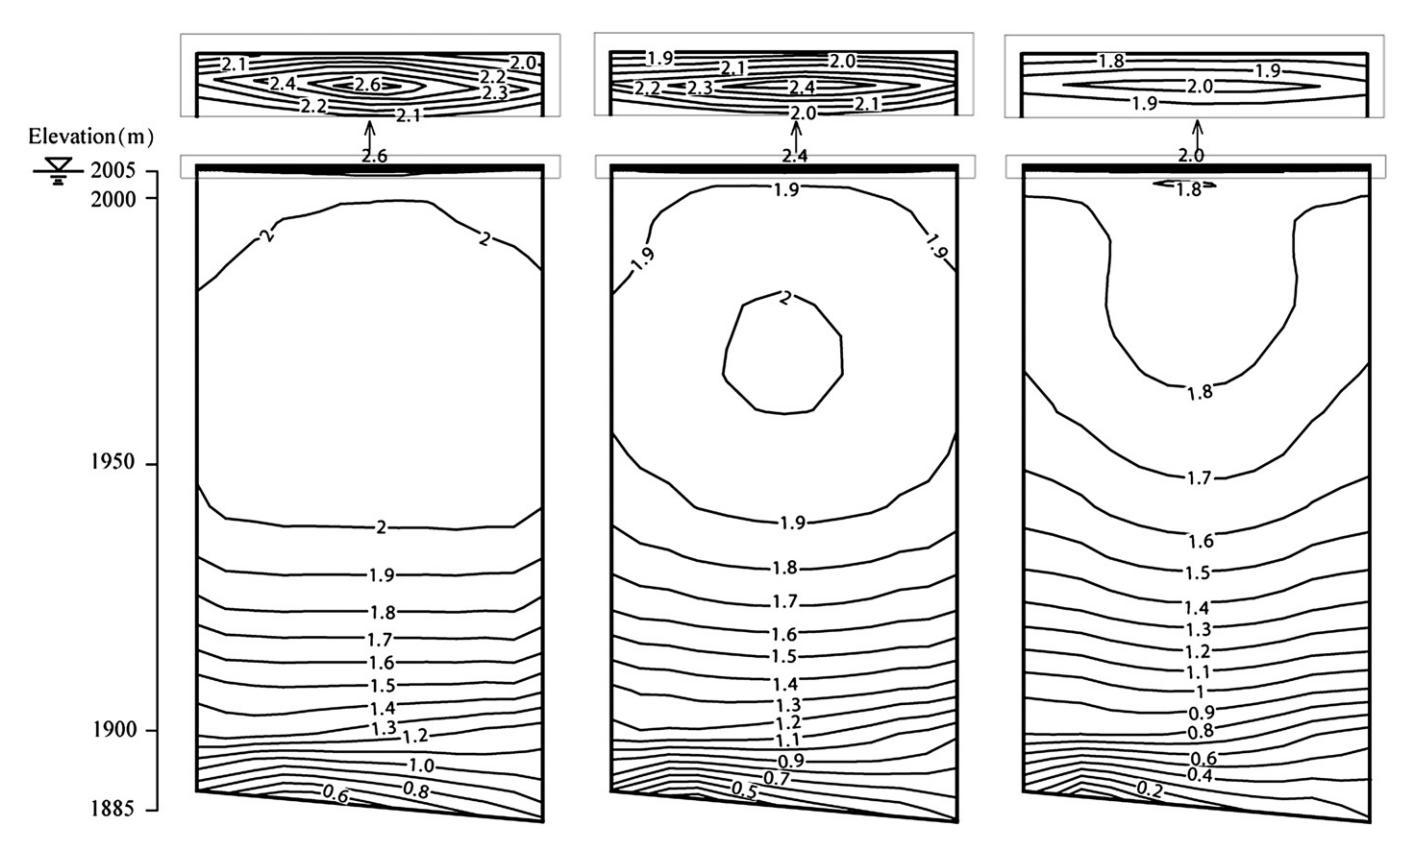
Fig. 13 shows that tensile stress on the outside surface of the face slab is higher than that on the inside surface. The highest tensile stresses of these two surfaces are 2.6 MPa and 2.0 MPa, respectively. They both occur at the top of the face slab near the water level, where the contour lines are very dense. Since this area possesses the greatest stress gradient, it is an area vulnerable to cracking at the top of face slab near the water level.

Fig. 13. Temperature-induced stress distribution of one face slab in the typical dam section at the lowest temperature (MPa).

slab stress. This FEM simulation only considers the effect of temperature field, so the stress in each dam section is assumed to be similar. We choose the typical dam section in the riverbed and draw its temperature-induced stress distribution, illustrated in Fig. 13.

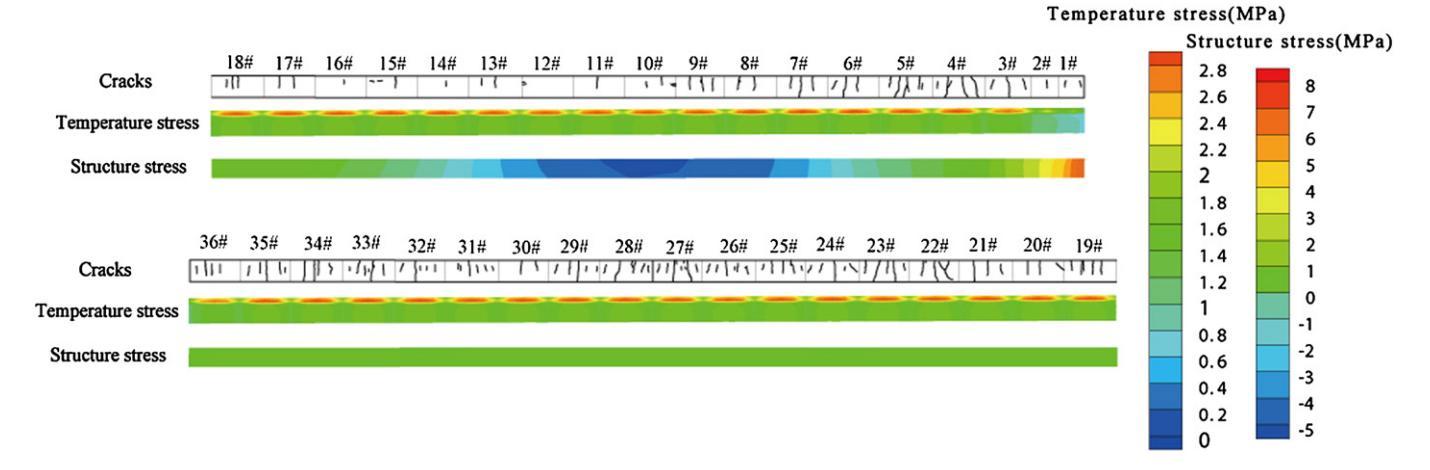
The cracks on the face slabs are caused by both temperature-induced stress and structure-induced stress. Maximum temperature tensile stress occurs mostly in the lowest temperature, i.e., at midnight on the evening of January 29, 2008. The temperature-induced stress and structure-induced stress at the top of the face slab at this moment are both evaluated, as shown in Fig. 14.

The temperature-induced stress simulation only considers the effect of the temperature field, so the temperature-induced stress of every dam section is identical. The maximum tensile stress (+) is 2.8 MPa. occurring at the water level on the top of face slab, which corresponds with the fact that the cracks mainly occur at the same place. The area of the face slab at the water level is at the junction between air and water. When in winter, the temperature of the face slab above the water level is low, while the underwater portion has a higher temperature. The temperature gradient at this place is great, leading to high levels of temperature tensile stress. When the air temperature is very low or strong cold waves exist, the temperature gradient at these sections increases even more, leading to cracking in the face slabs. The temperature tensile stress in the middle of one face slab is higher than that in both sides of the face slab, which corresponds to the fact that cracks in the middle of one face slab occur earlier than in both sides of the same slab

In the riverbed section (#6–#14), the structure-induced stress at the top of the face slab presents a pressure stress. The maximum value is 5 MPa, occurring at dam section #10. They are both bearing tensile stresses on the right and left banks. The terrain slopes gently on the left bank and steeply on the right bank, with structural tensile stress values of 1–2 MPa and 1–4 MPa, respectively. The maximum tensile stress occurs at the right end of the face slabs, with a value of 8 MPa. This value is too high because the grids here are next to the boundary, leading to the stress concentration.

Combining the effects of temperature-induced stress with those of structure-induced stress, the causes of face slab cracks can be effectively explained. On the riverbed section, stress is constitutive of temperature tensile stress and structural compressive stress, while on both bank

sides, it consists of temperature tensile stress and structural tensile stress. The tensile stress on both sides of the bank are therefore much higher than on the riverbed section, leading to many more cracks occurring on the bank's sides. Furthermore, the steep descent of temperature and a lack of surface heat preservation are the major reasons that the face slab on the riverbed section suffers more tensile stress, which is why there are a few shallow cracks developing in the riverbed section as well.

Fig. 14. Cracks, temperature-induced stress and structure-induced stress on the surface of the face slab above an elevation of 2002 m.

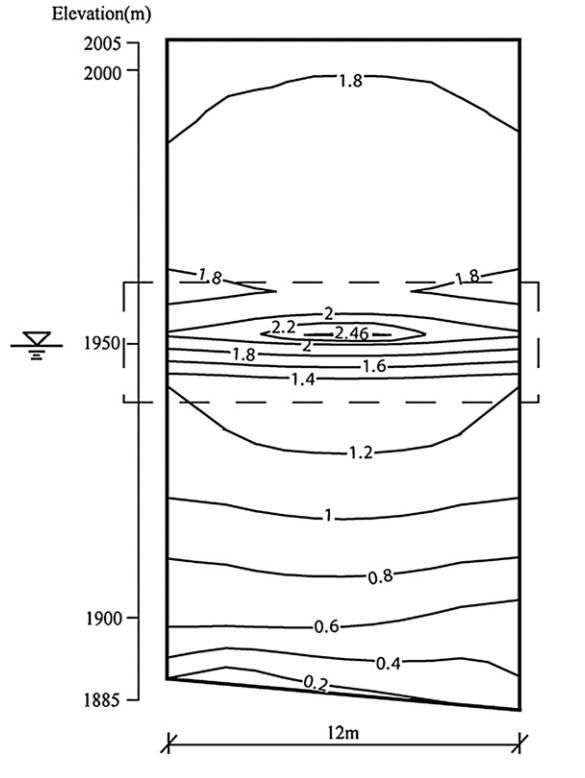
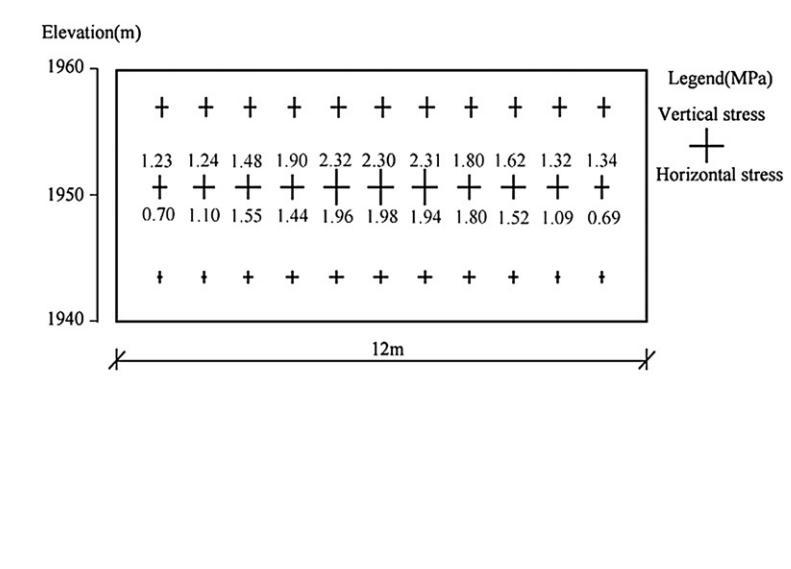
Fig. 15(a) shows that the maximum of the temperature tensile stress still occurs near the water level after altering the simulated water level, with a value of 2.46 MPa. In order to learn the direction of this stress, we magnify the area of the face slab in the dotted box and decompose the temperature tensile stress into two orthogonal directions (cf. Fig. 15(b)). The lengths of the vertical lines and horizontal lines present the values of the vertical stress and horizontal stress, respectively. Near the water level, the face slab suffers much more vertical stress than horizontal stress. The maximum of the vertical stress is located in the middle of the face slab near the water level, which is 2.32 MPa. Vertical stress plays the leading role and is the main cause of the horizontal cracks.

Fig. 15. Temperature tensile stress and its decomposition at a water level of 1950 m.

According to the existing face slab cracks in rockfill dams, most cracks occurring in these present projects are horizontal cracks, while the cracks involved in the Gongboxia rockfill dam are vertical cracks. Table 4 shows the changing water amplitude level for several similar projects. Compared with other similar projects, there is little change in the amplitude of water level at Gongboxia's reservoir. The normal water level is 2005.00 m, while dead water level is 2002.00 m. The difference between these two water levels is very small, only 3.00 m, taking up 2.3% of the total height of the dam. The water level of the reservoir is probably one of the most important factors causing the direction of the face slab cracks. In an effort to evaluate the effect of water level on these cracks, we altered the simulated water level to 1950.00 m and then calculated the temperature-induced stress of the face slab with the same calculating conditions (cf. Fig. 15(a))

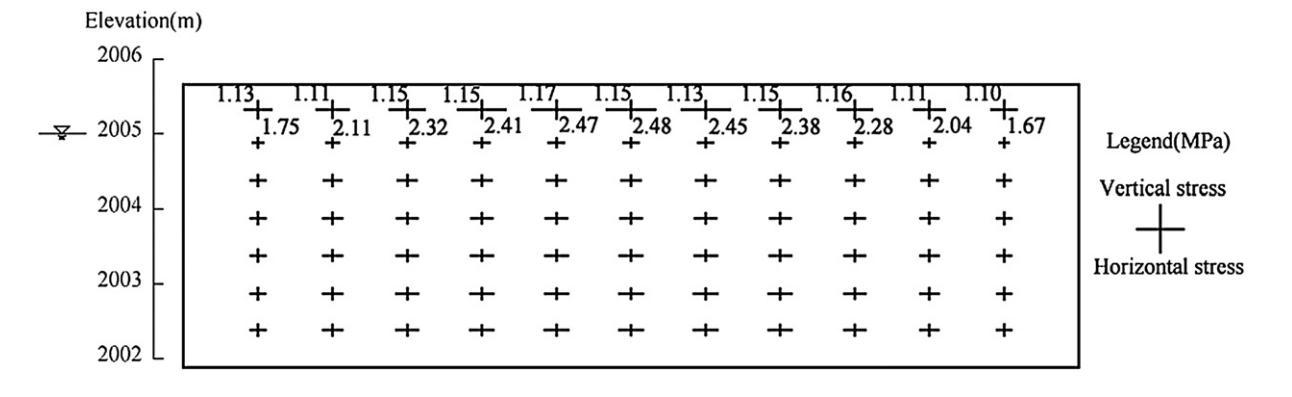
Fig. 16 shows the decomposition of the temperature tensile stress on the face slab near the water level when the simulated water level is 2005.00 m (normal water level). It can be seen that the face slab suffers much more horizontal stress than vertical stress, and the maximum of the dam axial stress is 2.48 MPa, occurring in the middle of the face slab near the water level. In this case, the horizontal stress plays a leading role and vertical cracks tend to develop.

From the perspective of mechanics of materials, when the water level is 2005.00 m (which is the normal water level of the Gongboxia's reservoir) the area of the face slab above the water level looks like a rectangle. The length (L) of this rectangle is much bigger than the height (h). For this area of face slab near the water level, the horizontal stress equals $E \cdot \varepsilon \cdot L$, while the vertical stress is $E \cdot \varepsilon \cdot h$, where E is the elastic modulus and ε is the strain of the face slab. L is much bigger than h, so horizontal stress is much greater than vertical stress. This is why vertical cracks tend to develop.

Fig. 16. Decomposition of temperature tensile stress on the part of face slab at a water level of 2005 m.
